# Intel<sup>®</sup> Celeron<sup>®</sup> Processor Specification Update

Release Date: February 02

Document Number: 243748-042

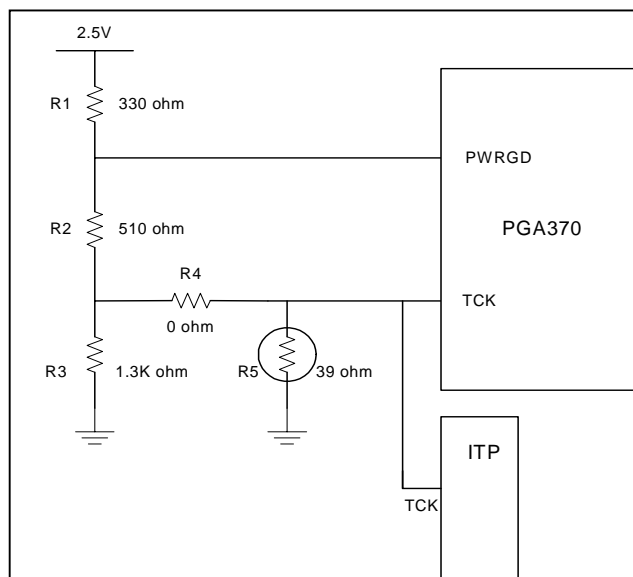
**Figure 1 Celeron® on 0.13 Micron Processor 256K Platforms Workaround**

In addition, the example workaround circuits shown do not support production motherboard test methodologies that require the use of the processor JTAG/TAP port. Alternative workaround solutions must be found if such test capability is required.

For Production Boards:  
*Depopulate R5*

To use ITP:  
*Install R5, Depopulate R4*
